Landesamt für Straßen- und Verkehrswesen

Monitoring Measurement on the Döllbach Valley Bridge

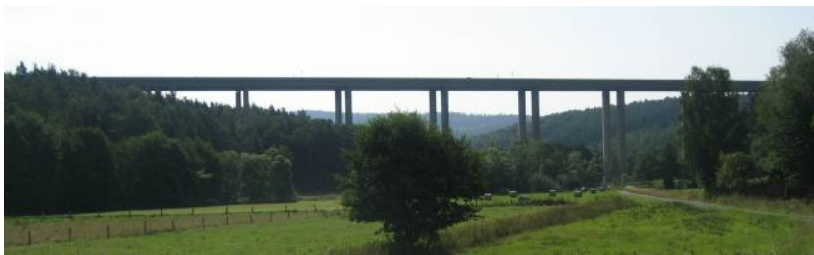
The Döllbach Valley Bridge is located in the vicinity of Fulda and is a part of the A7 Federal Freeway, one of Germany's most important north-south connections. At the time the bridge was built in 1968 the rapid increase in traffic, particularly heavy load traffic, was not foreseeable. Due to its age and high

stress resulting from use of thawing salt containing chloride, the structure shows considerable signs of corrosion. For this reason, it was decided to build a new bridge. For this purpose the

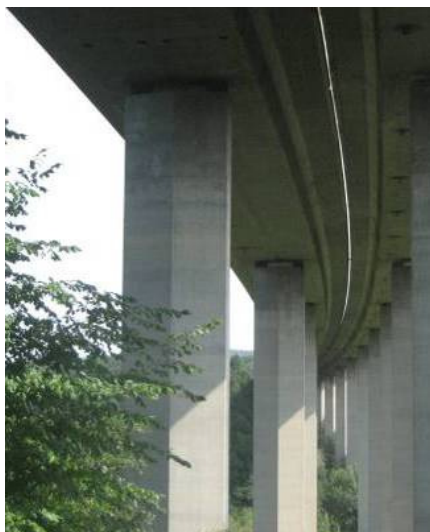
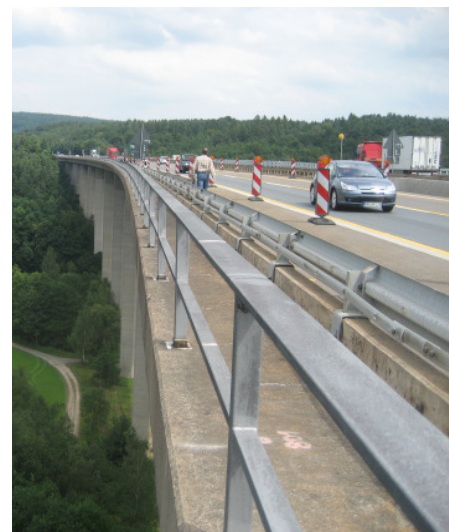
The prestressed concrete bridge consists of 2 separate roadways each with a width of 11.5 m and length of 576 m. It is subdivided in to 12 sections of 11 x 46 m and 1 x 70 m.

The maximum height is 52 m.

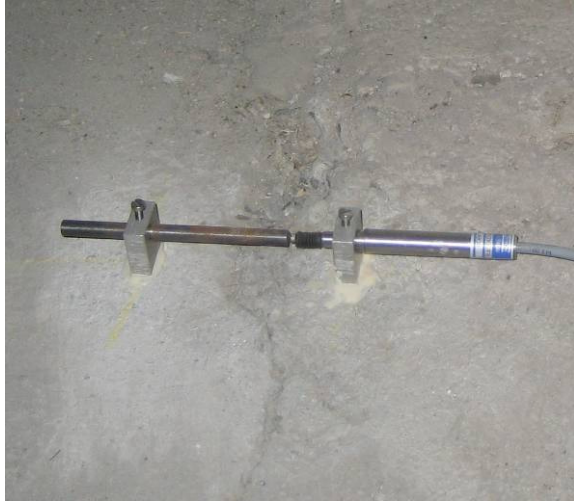
The primary values to be measured were defined as the changes in the fissure widths on the 2 x 12 coupling joints as well as 2 x 2 cracks in the roadway and one single crack in the bottom of the bridge. Moreover 6 measuring points were selected for the temperature, 2 measuring points for the concrete

moisture, one for measuring the pressure below the asphalt and 2 measuring points on the north and south abutments for measuring the bridge expansion. The 40 values are to be measured continuously and buffered locally, because only one GSM connection is available for transferring data. An alarm is to be triggered when certain, variably set limits are exceeded. The equipment was supplemented to include a video camera, which stores its image data on a local hard disk, to allow certain events such as traffic jams or heavy transports to be associated with the values measured.

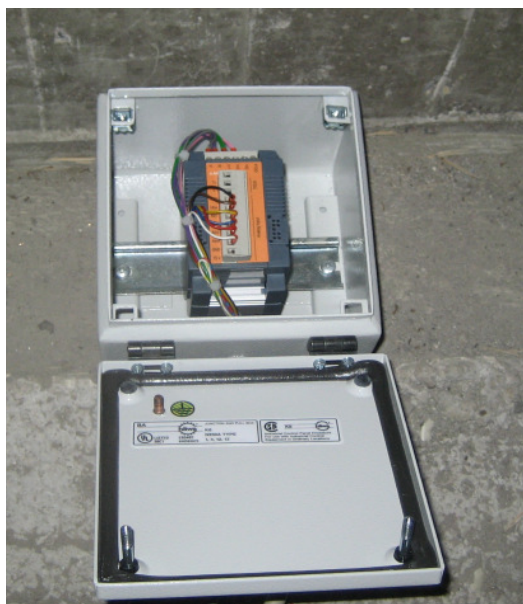
A carrier frequency amplifier type e.bloxx A6 from Gantner Instruments GmbH was connected to the measuring center using a bus cable. This bus cable serves as the power supply to the measuring point as well as for communication with the measuring center. This bus structure makes it relatively simple to add new measuring points to the system. The displacement of the fissures at the abutment joints is measured by WTH

series inductive displacement transducers from the Messotron Company. The e.bloxx A6-CF measuring amplifier offers, on the one hand, the input ranges required for inductive displacement transducers and, on the other, an RS 485 interface for establishing a bus structure. Moreover these modules are capable of capturing deformation changes at high scanning rates allowing calculation of the minimum and maximum values right in the module itself. It is then only necessary to transfer the extreme values to the center, drastically reducing the data rate. Pt100's connected to e.bloxx A5-1

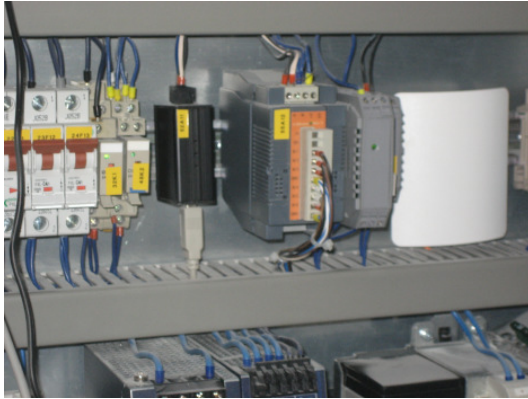
type measuring modules serve to measure the temperatures on the inside at the top and bottom of the bridge, the inner and outer temperatures as well as the sun radiation on the top of the bridge. The temperature inside the switch cabinet is also monitored for diagnostic purposes. A Hydromette M4050 from the GANN Company for measurement of the moisture in the concrete is also installed in series with a relay multiplexer for expansion of the measuring points.

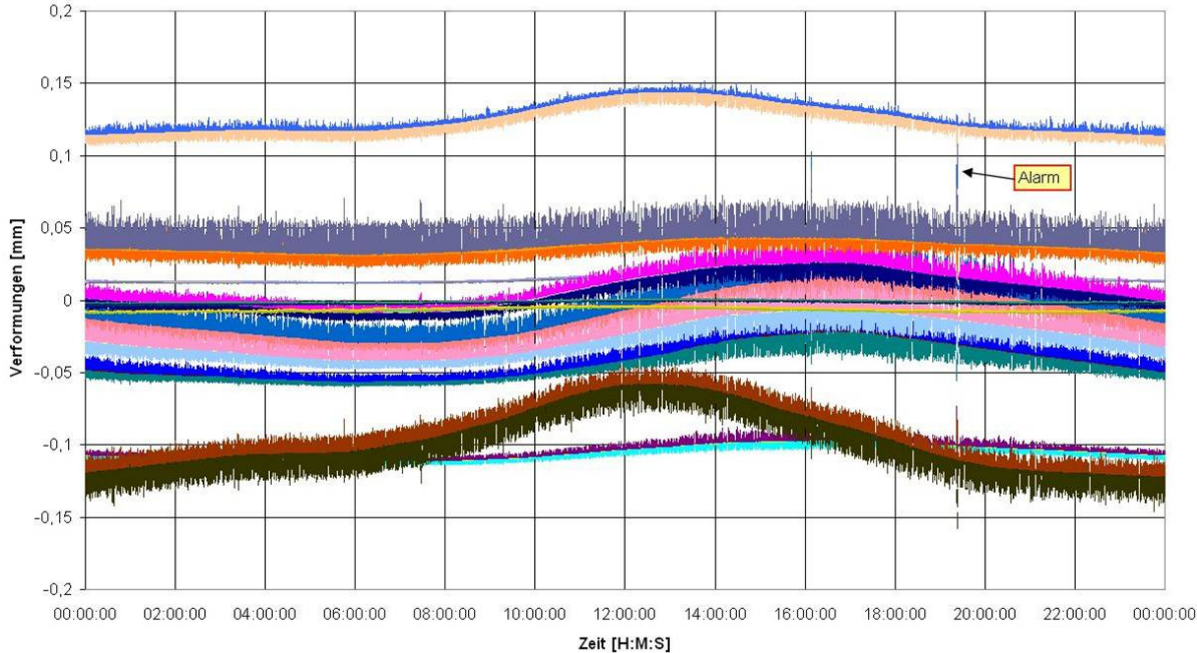
Measured Data with Alarm Message

The diagram shows the measured data for which an alarm was sent via SMS (marked with alarm in diagram). More precise evaluation showed that an increase was recorded at all measuring points. The chronological intervals of the increases and their chronological propagation allowed it to be concluded

that a heavy transport or overloaded vehicle crossed the bridge in the north-south direction. This was distinctly confirmed by evaluation of the camera images and corresponding chronological association.
